PATTERSON CREEK (RM 0.0–10.1), AUGUST 14–15, AUGUST 19–21, AND AUGUST 27, 2002

CANYON CREEK (RM 0.0–2.0), AUGUST 20–21, 2002

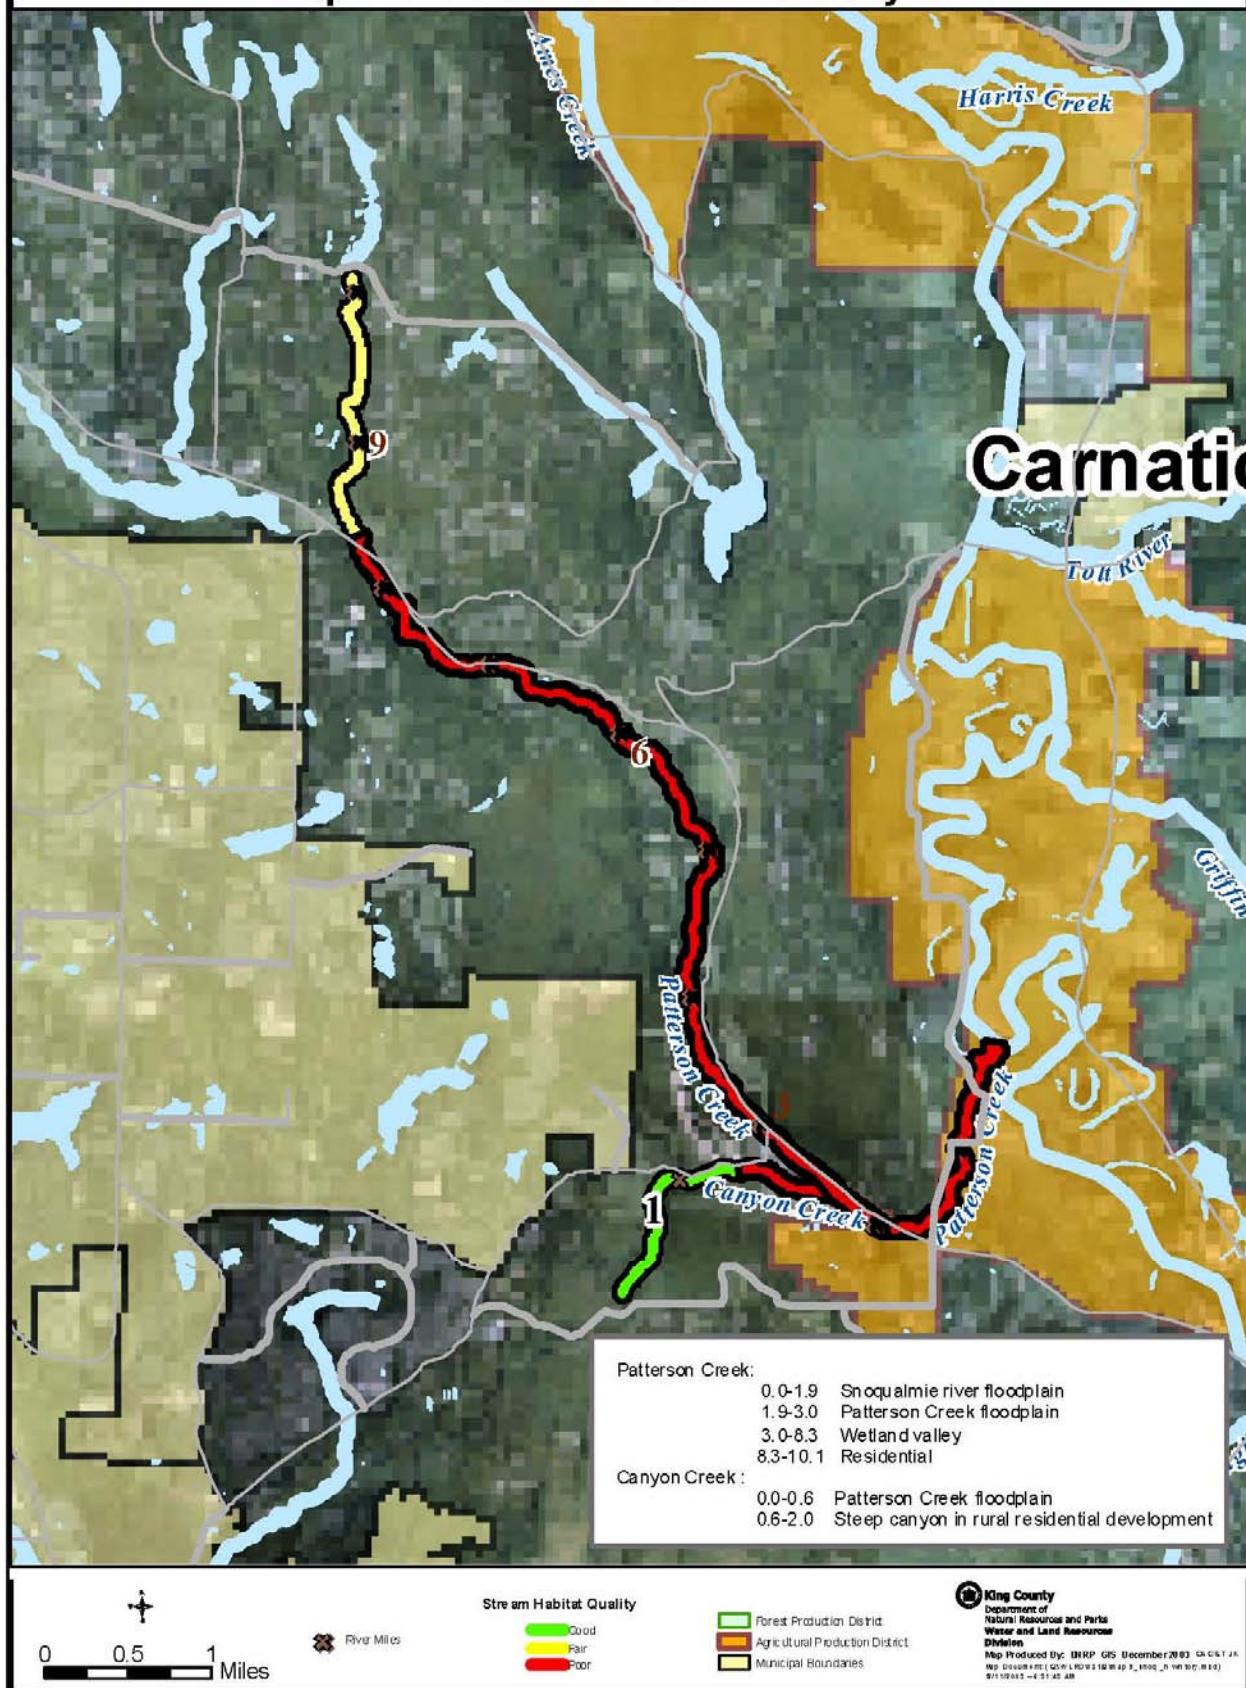
Photo PA1. Patterson Creek floodplain.

Patterson Creek followed SR 202, flowing within 100 feet of the roadway throughout this reach. The creek was straight and deeply entrenched (Photo PA1). The substrate was predominantly silt with patches of gravel and pebble. The shallowest water was only 2.9 feet in depth; in other locations the water was too deep to measure. At RM 2.9 the flow was subsurface. The wetted width was approximately 10 feet, and the OHW was 24 feet wide.
